CIA/PIR-77035

NAN-KOU MILITARY COMPLEX NAN-KOU, CHINA 40 10N-116 09E

The scope of this report is primarily concerned with the armored military activity that is located near Nan-kou. The detailed analysis of this military complex is presented from photography of however, photography from eight different missions is used for comparative purposes, and all of the referenced photography was utilized in the overall analysis.

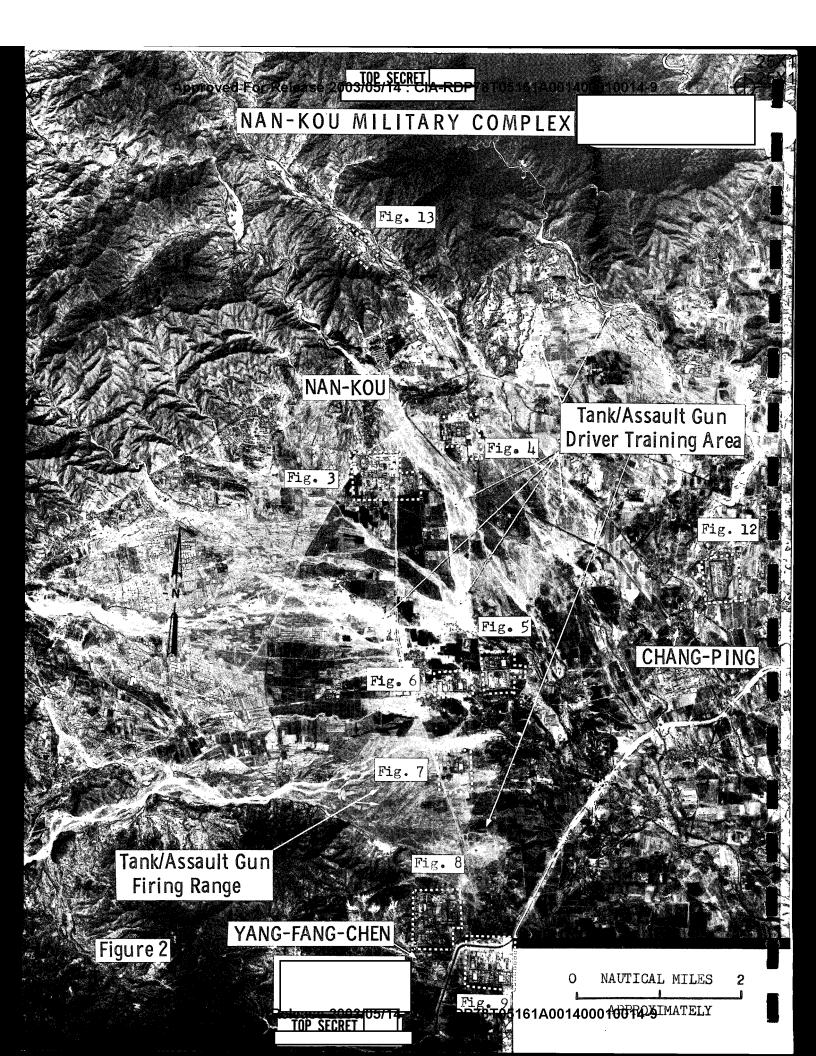
The Nan-kou Army Barracks and Ammunition Depot SW is located approximately 1 nm SW of Nan-kou. Significant changes have occurred at this installation since photography of	25X1 25X1

(A) Billeting Area (Figure 3)	
74 Probable barracks buildings (31 new since Probable administration buildings (one new since	25X1 25X1
4 Probable messhall buildings 1 Possible messhall building (new since 1 Auditorium building (wings added after 45 (Approximate) storage/support buildings of various sizes	25X1
1 Swimming poolempty (new since l Possible firing range l Water tower	25X1

(B) Tank/Assault Gun Maintenance Facility (Figure 3)	
This area appears to be a higher echelon maintenance facility with more sophisticated facilities for the maintenance and overhaul of heavy vehicles. The three small buildings that are marked with red dots are new since photography of	25X1

Tank/Assault Gun Maintenance and Storage Facility (Figure 3)

Eight new buildings have been added to this area since The building layout in this area is similar to the building layout in other tank/assault gun facilities in China.

(D) Tank/Assault Gun Subcaliber Firing Range (Figure 3)

This area contains a 100 meter firing range.

(E) Explosives Storage Area (Figure 3)

This is a secured area that contains twelve dispersed explosives storage buildings and six support buildings. Two fences enclose the area.

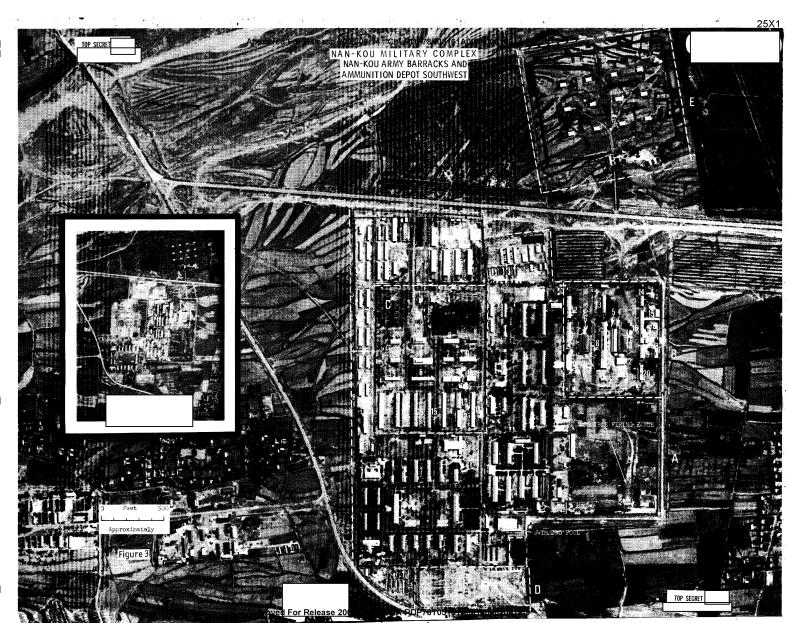
This military installation is located immediately south of Nan-kou. There are no rail facilities within the installation; however, more than adequate rail facilities are located in the city of Nan-kou (See Figure 4). The only significant change that has occurred to this installation since is the new construction activity that is photography of noted in Area "A" on Figure 4. Within areas "B" and "C" a total of 15 T-34/T-54 tanks and 3 cargo trucks were observed--they are indicated on Figure 4 by small arrows.

(A) Billeting Area (Figure 4)

The billeting area is surrounded by a wall and contains the following buildings and facilities:

- 21 Probable barracks buildings
 - 2 Probable administration buildings
- 2 Messhall buildings
- 1 Auditorium building
- 12 Storage/support buildings
- 1 Swimming pool

One new possible barracks building and foundations for two possible buildings are under construction in this area, and numerous animal pens and small sheds are scattered throughout the area.

(B) Tank/Assault Gun Storage and Maintenance Facility (Figure 4)

This area is secured by a fence and contains the following buildings and facilities:

6.	Support	building				
7.	Vehicle	storage building	85	Χ	35	ft.
8.	Vehicle	storage building	85	X	35	ft.
9.	Vehicle	storage building	250	Χ	35	ft.
10.	Vehicle	storage building	250	Χ	35	ft.
11.	Vehicle	storage building	260			
12.	Vehicle	storage building	120	Χ	40	ft.
13.	Support	building

(Buildings 7, 8, 9, and 10 appear to house tracked vehicles while buildings 11 and 12 may house only cargo trucks and wheeled equipment -- note road pattern and interior fencing.)

(C) Tank/Assault Gun Subcaliber Firing Range (Figure 4)

This facility consists of a subcaliber firing range with two probable moving target runs and two support buildings. Two T-34/T-54 tanks are indicated by an arrow on Figure 4.

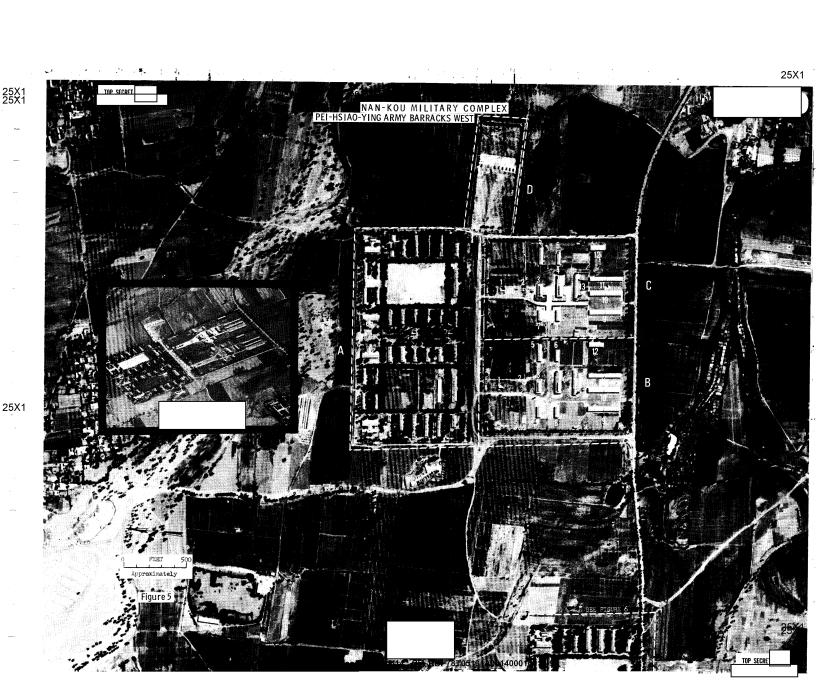
This military installation is located approximately 3.5 nm SSE of Nan-kou (See Figures 2, 5, 6 and 7). Activity throughout this installation appears to be at a medium level. Few changes have occurred to the buildings and grounds since photography of _______ Five new buildings (new since _______ are indicated on Figures 5 and 7 by orange dots. A total of 21 T-34/T-54 tanks and 11 possible SU-76 assault guns were observed within this installation.

(A) Billeting Area (Figure 5)

- 26 Probable barracks buildings
- 3 Probable administration buildings
- 4 Probable messhall buildings
- 1 Auditorium type building
- 5 Storage/support buildings

(B) Tank/Assault Gun Storage and Maintenance Facility (Figure 5)

Little change is evident within this area since photography of A total of three cargo trucks were observed within this area on photography.

(C) Tank/Assault Gun Storage and Maintenance Facility (Figure 5)

The facilities within this area are almost identical to the facilities within Area "B". The building plan and the sizes are for the purposes of analysis identical. The mensuration data presented in Area "B" can be applied to this area in the same itemized sequence. Five probable tanks are located near Item 2 -- the vehicle maintenance ramps.

(D) Tank/Assault Gun Subcaliber Firing Range (Figure 5)

This area contains an active 100 meter subcaliber firing range. Eight tanks (possible T-54s) are located on the range in Figure 5.

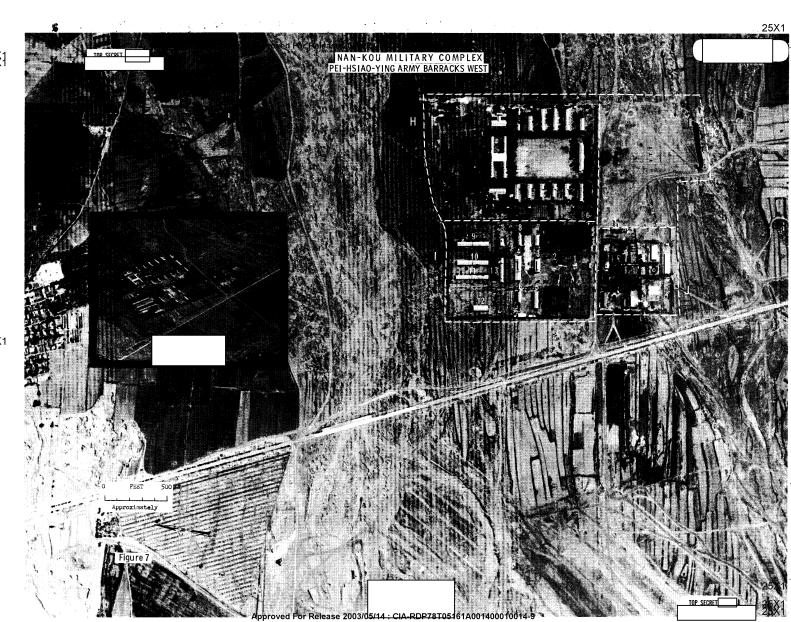
(E) Billeting Area (Figure 6)

- ll Probable barracks buildings
- 1 Probable administration building
- 2 Probable messhall buildings
- 4 Storage/support buildings
- 1 Water tower
- Basketball courts Auditorium type building

(F) Tank/Assault Gun Storage and Maintenance Facility (Figure 6)

The building plan of this facility is nearly identical to the facility reported in Areas "B" and "C". Slight varitions are found in building locations and sizes.

(G) Tank/Assault Gun Subcaliber Firing Range (Figure 6)

This area contains a 100 meter firing range and three support buildings. Six tanks (possible T-54s) and one truck are indicated by arrows on Figure 6.

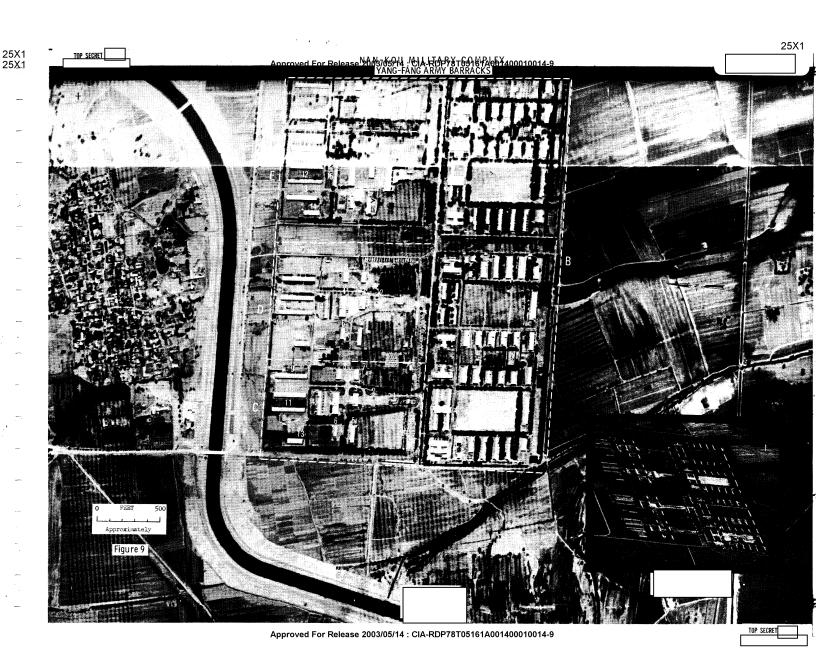
The Yang-fang Army Barracks consists of two separate areas (See Figure 2) and is located approximately 6 nm south of Nan-kou and immediately north of Yang-fang-chen. The installation shown on Figure 8 appears to be a possible headquarters and billeting area. Figures 10 and 11 show an overall view of that portion of the Yang-fang Army Barracks that was not covered by photography of ______ These two Figures also show new building construction and the rapid construction of a new canal that passes near the installation. The only new construction of significance that was noted at this installation was the construction of 4 new buildings in a vehicle storage/maintenance area (See Figures 9, 10 and 11).

- (A) Billeting Area--Possible Headquarters (Figure 8)
 - 56 Probable barracks buildings
 - 5 Probable administration buildings
 - 5 Probable messhall buildings
 - 75 (approximate) storage/support buildings
 - 6 Probable cargo trucks (see arrow)

Other facilities include a water tower, swimming pool, basketball courts, athletic fields, and probable animal pens.

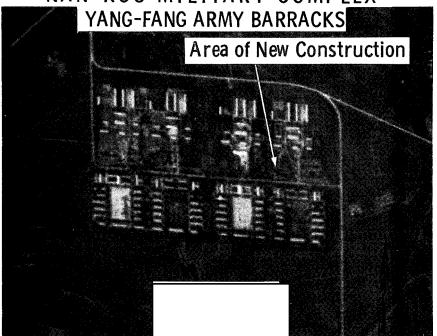
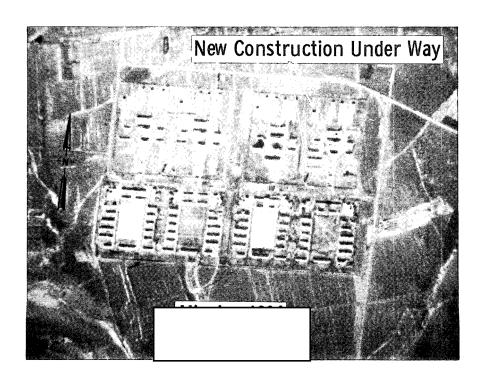
(B) Billeting Area (Figures 9, 10 and 11)

Within this area are four similar billeting areas which have been for the purposes of analysis combined into one large area.

(C) Tank/Assault Gun Storage and Maintenance Area (Figure 9)

No significant changes are apparent within this area since photography of Trucks are the only vehicles that have been observed within this area; however, the building pattern for this area is the same as the building pattern in the previously reported tank/assault gun facilities.

(D) Tank/Assault Gun Storage and Maintenance Area (Figure 9)

This area appears to have a lower level of activity than other similar areas that are included within this report. The traffic pattern within the area seems to vary somewhat from the other tank/assault gun facilities. A functional modification of the area may have taken place.

Vehicle Storage and Maintenance Area (Figure 9)

Some variations are noted within this area when compared to the tank/assault gun storage and maintenance areas that are included within this report. This area is possibly only utilized by wheeled vehicles. One building (indicated by dot) is new since photography of

(F) Vehicle Storage and Maintenance Area (Figures 9, 10, and 11)

Mensuration data for buildings within this area is not presented due to the lack of good quality photography. Five new buildings (See dots Figure 9) were constructed since photography _______ This area, with the exception of the new buildings, is very similar to the tank/assault gun areas that are reported in other sections of this report.

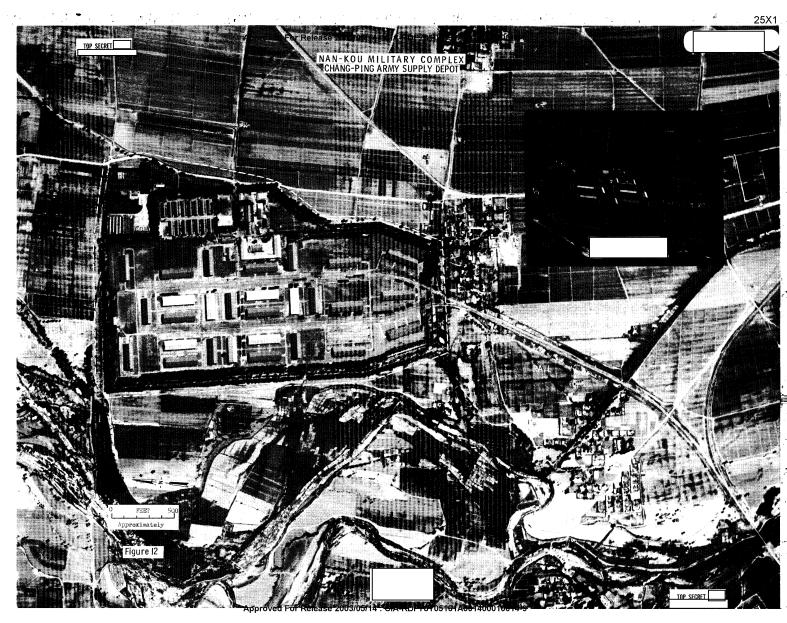
This rail served supply depot is located approximately 4 nm SE of Nan-kou and immediately to the NE of Chang-ping (See Figure 2). The proximity of this installation to the armored installations that are included within this report indicates that a relationship probably exists. Comparative photography of indicates that no significant change has occurred within this area. The entire installation is secured by two fences. Five rail cars and a crane are indicated on Figure 12 by arrows. Several large packing crates/stacks of material were observed adjacent to the rail spurs within the installation.

28 Storage buildings

- 16@ 260 X 80 ft. 12@ 200 X 80 ft.
- 15 Probable barracks buildings
- 3 Probable administration buildings
- 12 Support buildings
